## Software Maintenance Release Note

# Version 276-03

### for AT-8900 and AT-9900 series switches

This software maintenance release note lists the issues addressed and enhancements made in Maintenance Version 276-03 for Software Release 2.7.6. Release details are listed in the following table:

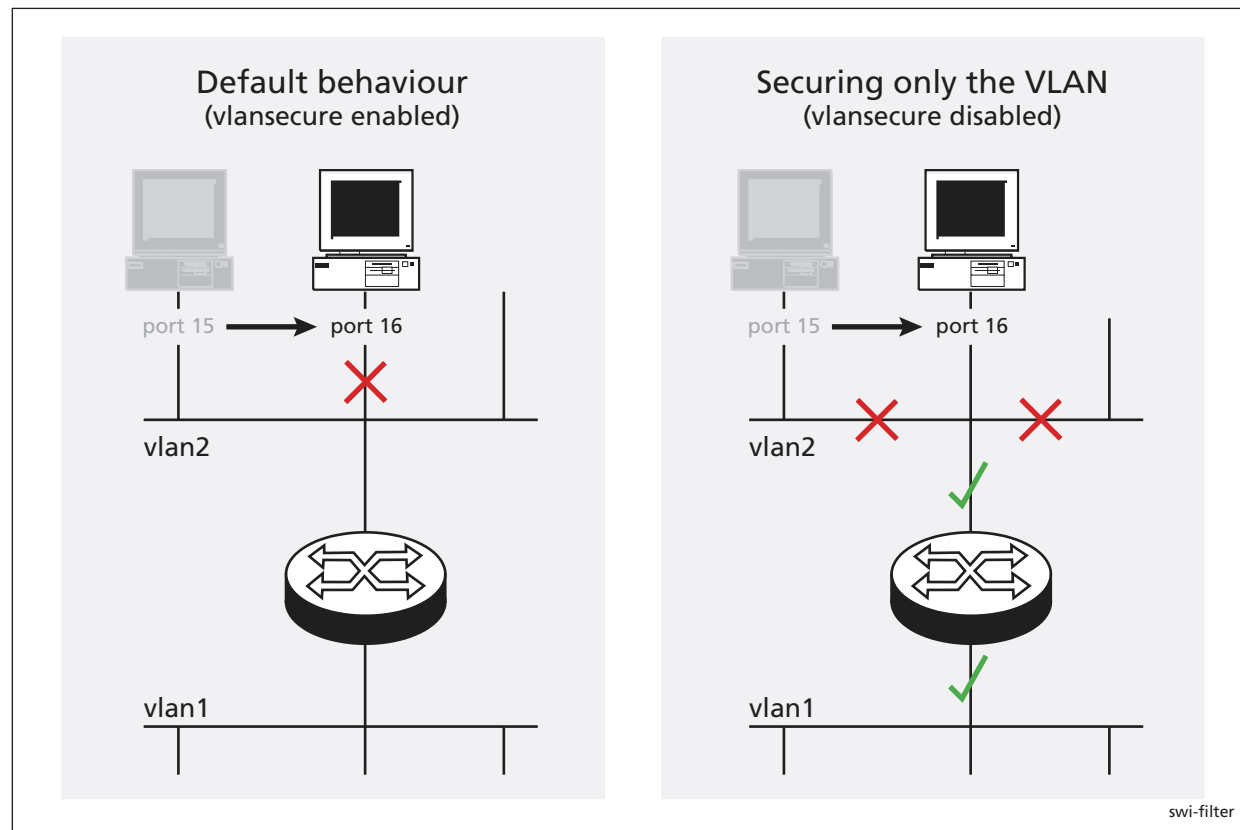
With this enhancement, the above filter limits the host to accessing vlan2 through port 15, but does not prevent the host from accessing other VLANs through other ports in vlan2. For example, if the above filter exists and you move the PC to another port in vlan2, this enhancement prevents the PC from communicating with devices in vlan2 but allows it access to other VLANs on the switch. The following figure shows a PC that has been moved from port 15 to port 16 to illustrate the effect.

```
add switch filter entry=0 dest=pc-mac-address vlan=2 port=15 action=forward
```

To turn off the default behaviour, so that the filter prevents access to only the current VLAN when you move the host, use the new command:
